Manhole Inspection Summary

Manhole # S33M__010MH

Insp Date: **8/12/08 2:06 PM**

Location Address: **516 s hanover st**

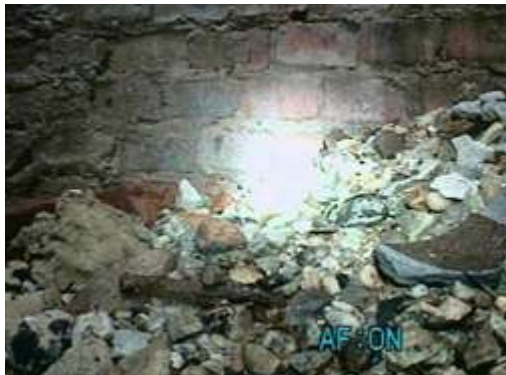
Defect 4

Condition: ☐ Sound ☐ Cracked ☐ Root Intrusion ☐ Deteriorated ☐ Leaks ☒ **Debris**

bench debris

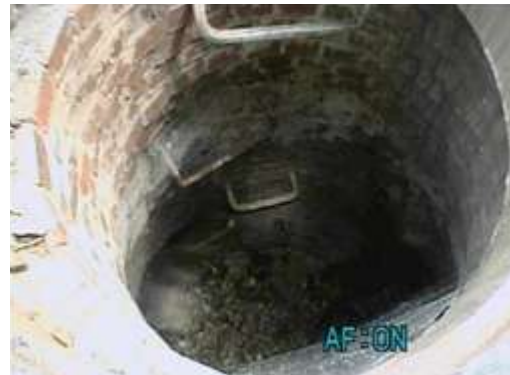
Defect 3

Steps Count: **5** Missing: **0** ☒ **Corroded**

steps

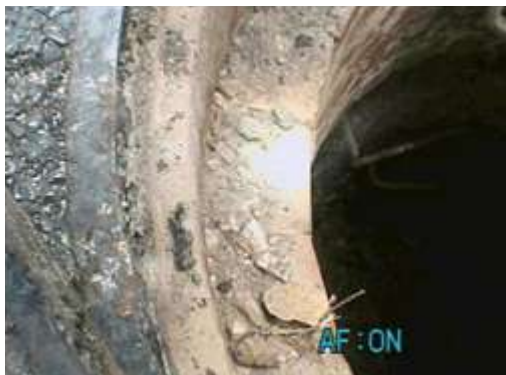
Defect 2

Frame Offset: **4** (in.) Condition: ☒ Sound ☐ Cracked ☐ Leaks

offset

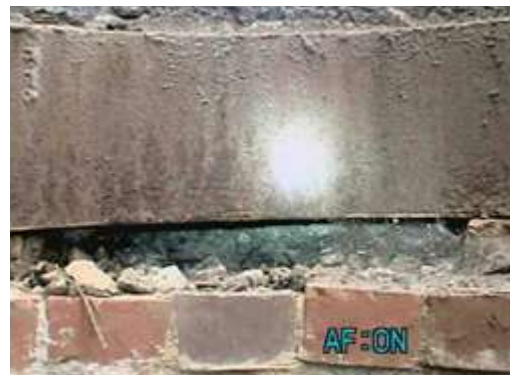
Defect 1

Chimney / Frame Adjustment ☒ Exists Material: **Brick and Stone** ☐ Parged Height: **2** (in.)

Condition: ☐ Sound ☐ Cracked ☐ Root Intrusion ☒ **Loose Brick** ☒ **Deteriorated**

chimney loose bricks,deteriorated, frame adj

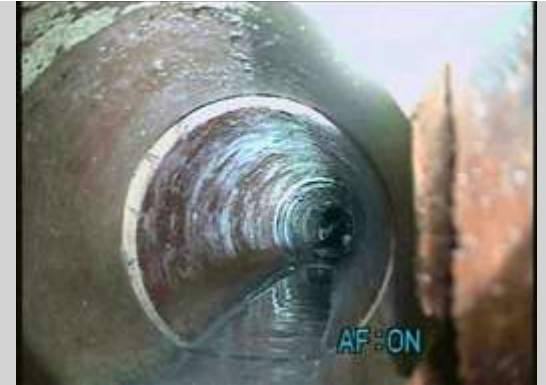
12 O'Clock Outflow

8 in. Circular Gravity Sewer
Pipe Out @ 12 O'Clock

Invert Depth: **9.44** (ft.) Flow Characteristics: **Slow**

Infiltration: **None** Pipe Seal Cond: **Unknown**

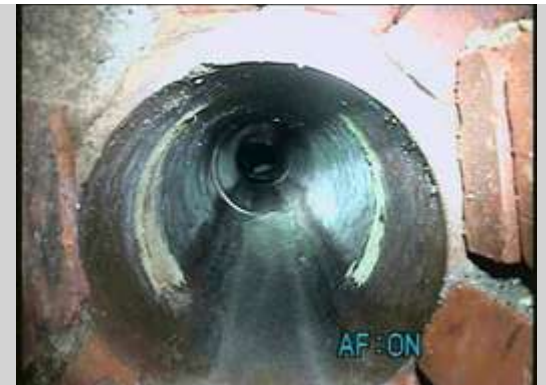
3 O'Clock Inflow

8 in. Circular Gravity Sewer
Pipe In @ 3 O'Clock

Invert Depth: **9.40** (ft.) Flow Characteristics: **Slow**

Infiltration: **None** Pipe Seal Cond: **Unknown**
